**Cathedral Cove Basic Level  
Landslide Risk Assessment**

**Prepared for**  
Department of Conservation  
**Prepared by**  
Tonkin & Taylor Ltd  
**Date**  
July 2023  
**Job Number**  
1007838.3000 v3

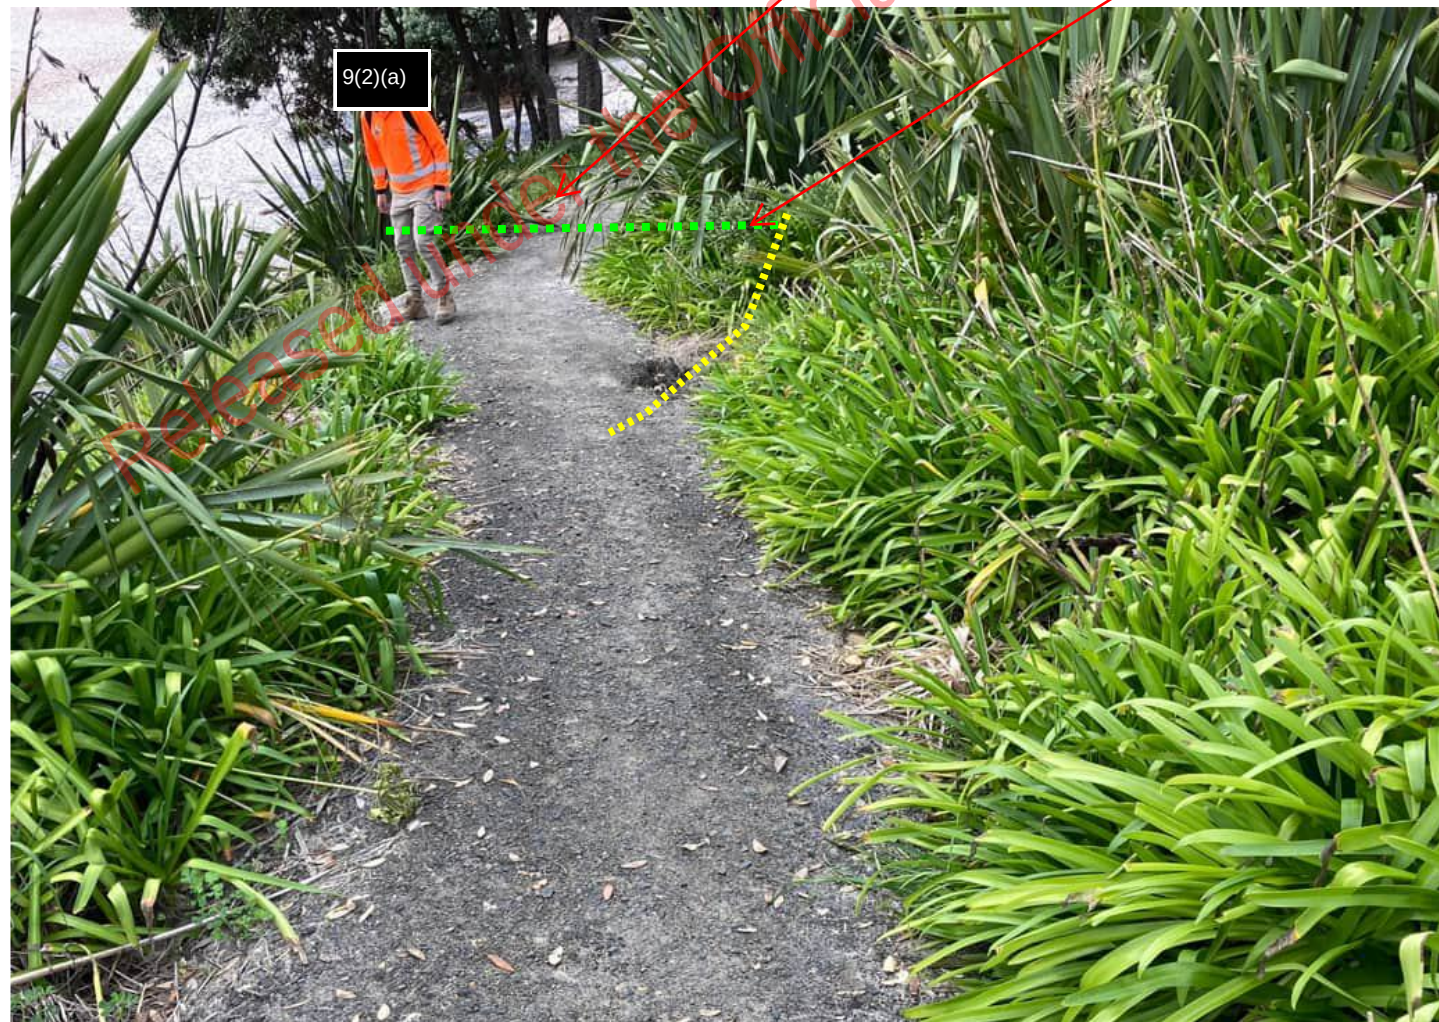
17/05/2023

Wall has bowed out slightly. No  
new movement is observed.

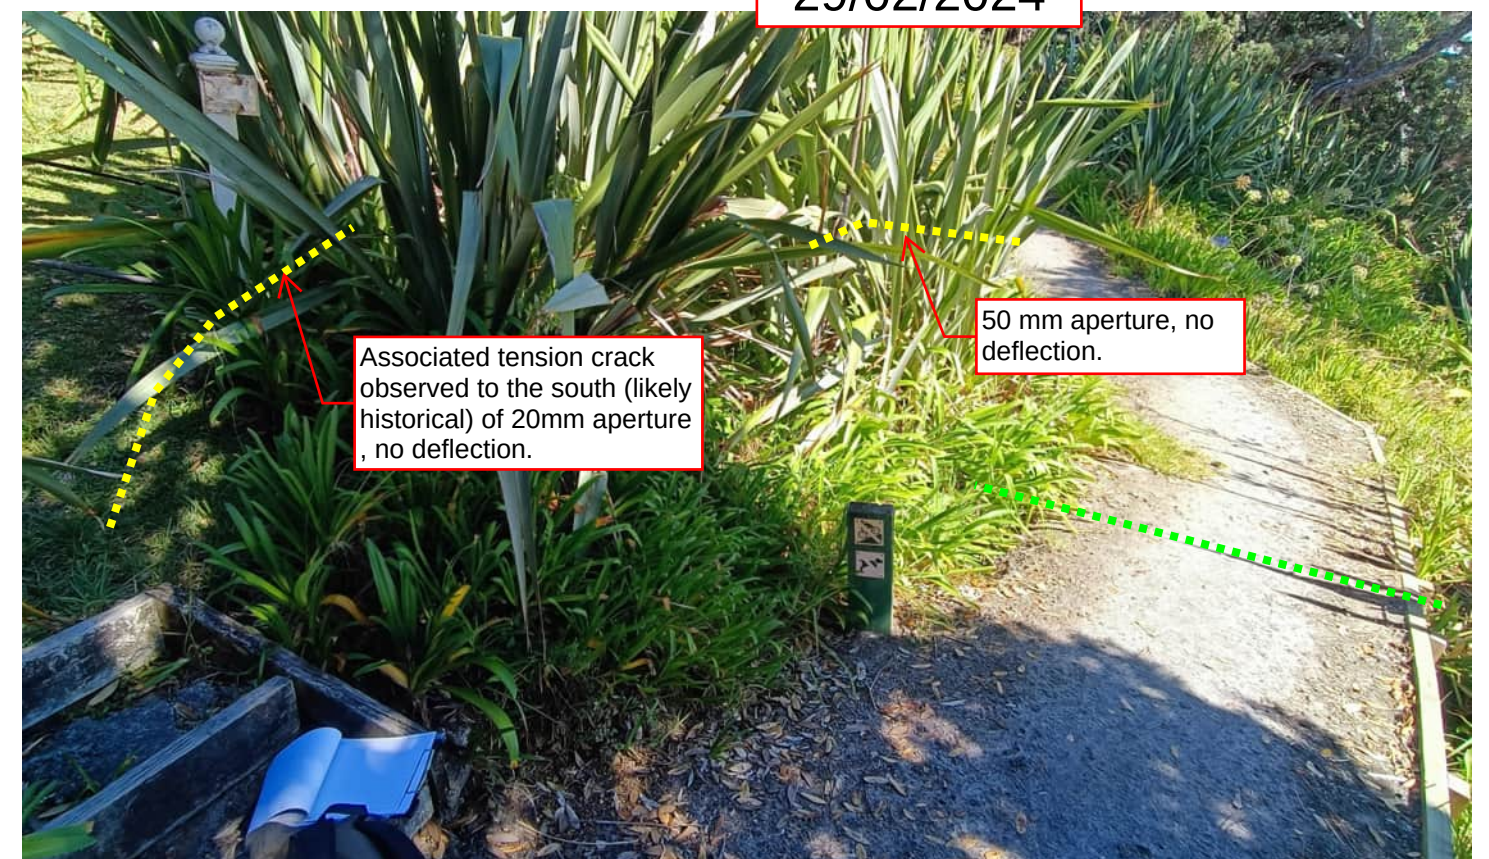
29/02/2024

Feature 53 Continued - No new damage  
observed during May 2024 visit.

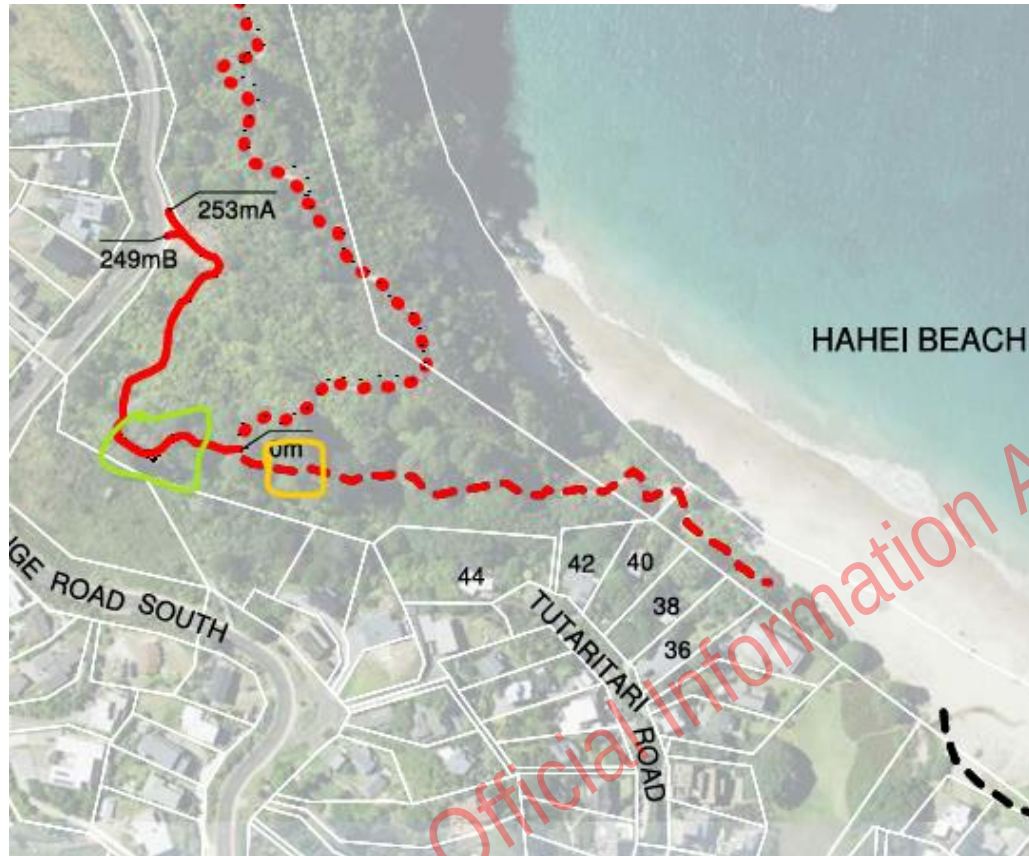
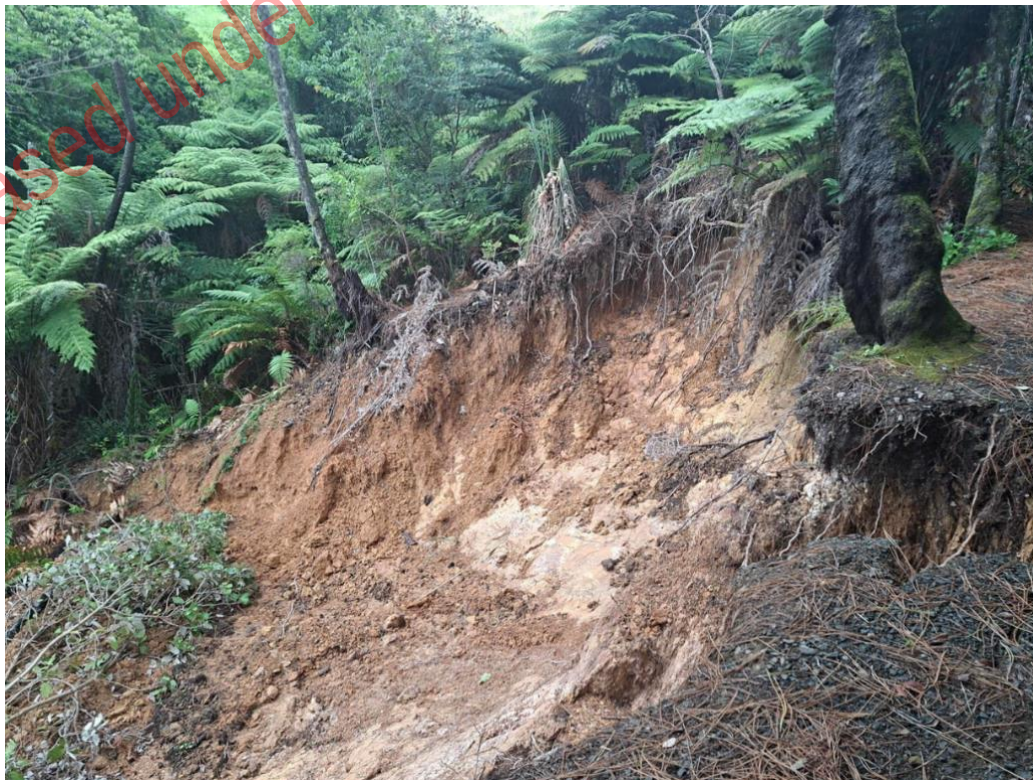
Figures 2 & 3: Landslide and track damage: Photos DOC

25. This site damage was assessed as major, with repair requiring funding beyond the district budget<sup>7</sup>. It was confirmed there is no funding available to undertake the works required to repair this new slip area. This aligns with DOC prioritising limited capital investment toward resilient, high value assets and core visitor experiences, while reducing exposure to assets that are vulnerable, high maintenance, or unlikely to deliver reliable outcomes.
26. The next step of the assessment is to consider visitor site criteria, importance of the site and climate change and natural hazard risk modelling.
27. The Hahei Walk has known geological instability confirmed by geotechnical reports. Previously bridges have been placed to cross historic landslides. These were assessed as needing replacement due to foundation issues.

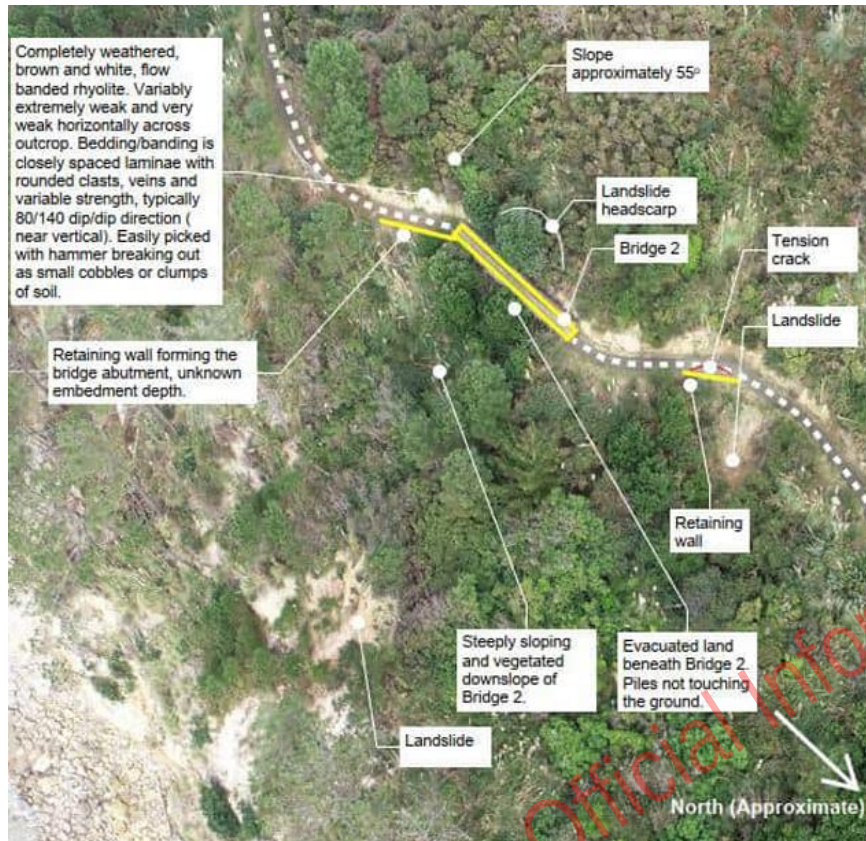
- Evidence of historic landslides upslope and downslope of the track and bridges.
- Bridge piles not touching the ground.
- Steep 50-degree slopes highly possible for landslides.
- Potential for further landslides upslope and downslope.
- Unstable and weak ground conditions above high cliffs.
